INDIVIDUAL INVENTORY FORM

NHDHR INVENTORY NUMBER: CON0190

1. Historic name: A.S. Smith Farm-
Maplewood Farm
2. District or area: Stickney Hill
Agricultural Neighborhood
3. Street and number: 62 Stickney Hill Rd.
4. City or town: Concord
5. County: Merrimack
6. Current owner: William & Marguerite
Bunten

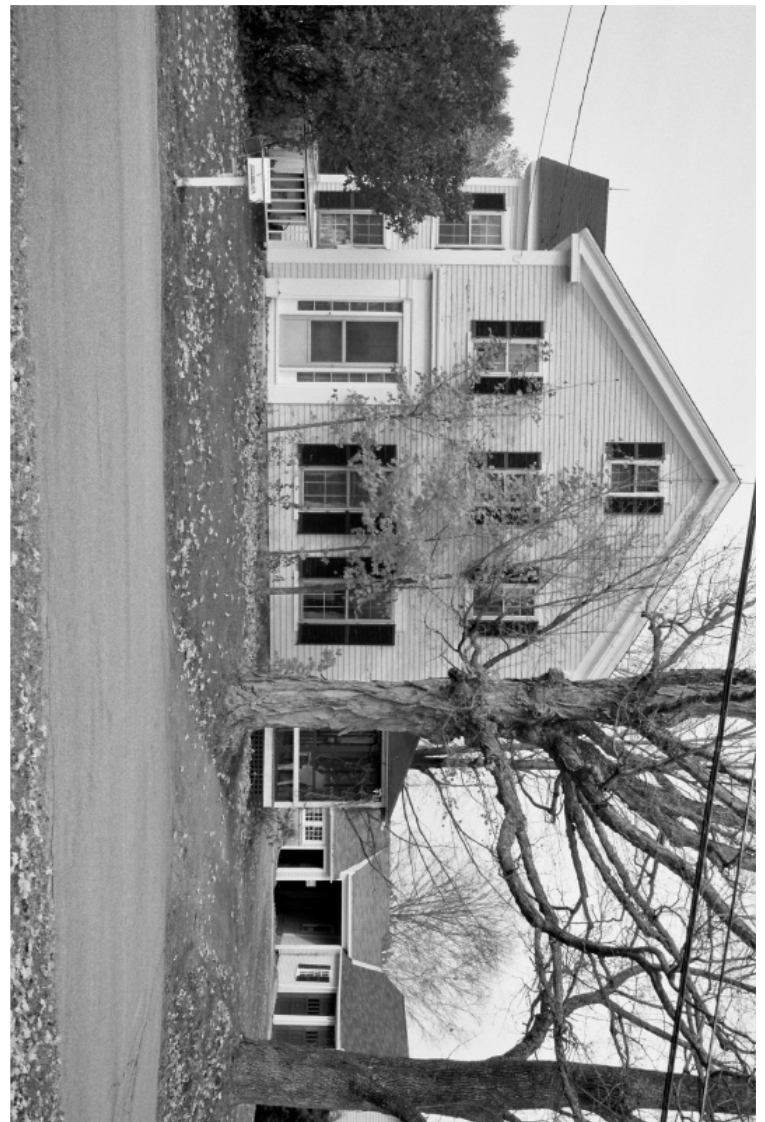
35. Photo #1

Description: Farmhouse; milkhouse & garage at far left

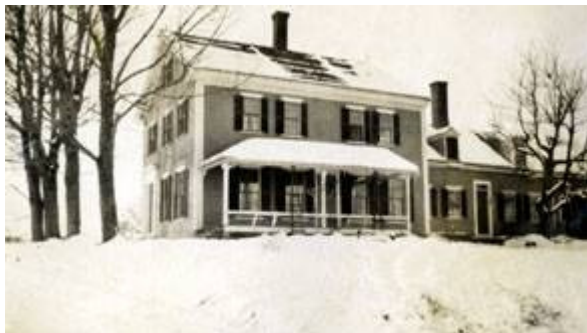
62 Stickney Hill Road, photographed mid-20th century. *From Amsden, A Capital for New Hampshire, Chapter 17, opposite page 8.*

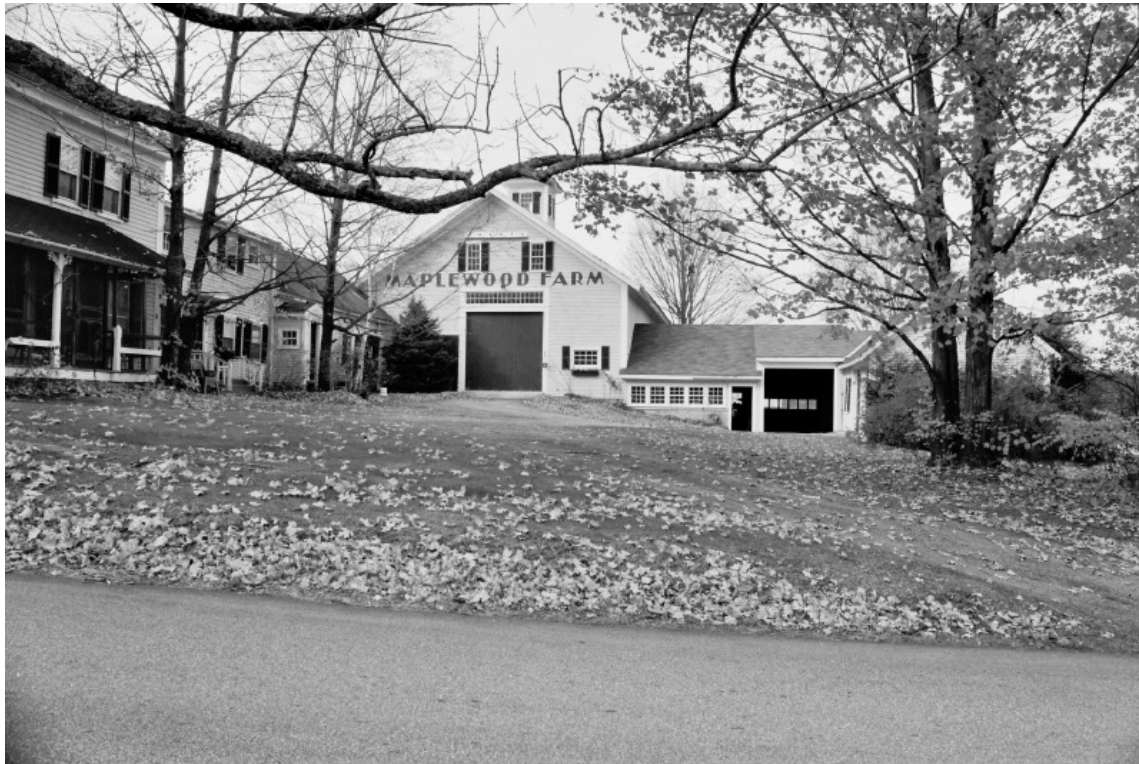
Photo 2 description: View of barn yard, showing from left: house, ell, shed, barn, milk house, garage
Roll: 6 Frame: 13 Direction: NW

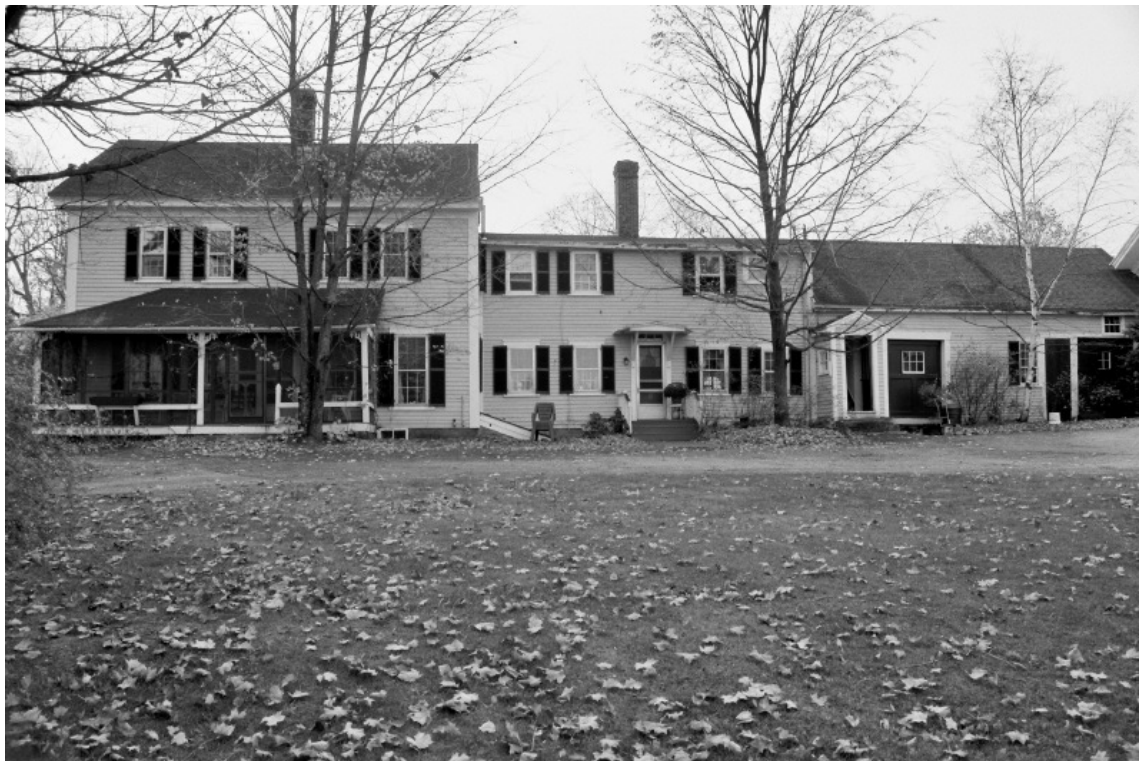
House (ca. 1855): The farmhouse is a 2 ½ story, gable-front, sidehall structure with rear ell sited close by the road. Walls are clad with clapboard and trimmed with cornerboards, cornice returns and flat casings. Windows have 6/6 sash and louvered blinds. The full sidelights and architrave of the main entrance are Greek Revival stylistically. Along the east elevation, there is a shed-roof porch with scroll brackets that likely dates from the late 19th c. A two-story, five-bay wide ell extends to the rear. (It was originally 1 ½ stories and raised to a full two stories by the Buntens to create an apartment. The historic photograph shows that prior to the alteration it had two gabled dormers on the east slope.) The east (main) entrance of the ell is narrow and features a transom light above—both typical on an early 19th century residence. (A thorough inspection might reveal that the ell pre-dates the house. If so, it may have once been the main house.)

Shed (mid-19th c.): The 1 ½ story shed is attached to the ell in a continuous ridge line. An enclosed, gabled entry portico projects toward the south end. Remaining openings have rolling doors or a mix of sash: 9/6, 6/6 and six-light. A shed-roof extension spans most of the rear (west) elevation.

Photo 3 description: East elevation of house, ell & shed
Roll: 6 Frame: 16 Direction: SW

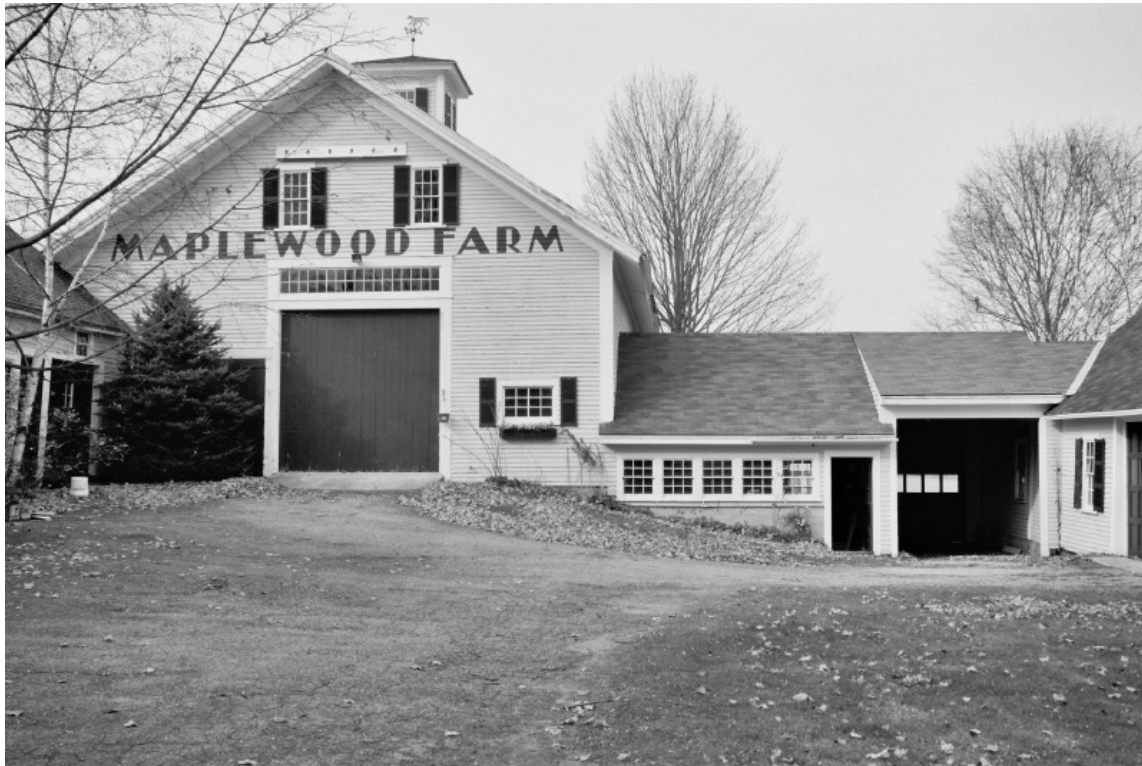
Roll: 6 Frame: 15 Direction: NW

Barn (mid-19th c.): The barn is attached to the shed, offset to the east. It is a gable-front structure with clapboard siding and metal roof. A square ventilator with a hip roof and 6/6-sash window in each face crowns the ridge. The interior was not available for an inspection beyond the front entrance; only the following could be seen: it has six bays (the north two bays are those that came from across the road and may date from the late 18th c.), a common rafter roof, and scaffold over the main drive floor.

Milk house (mid-20th c.): This is a one-story structure attached to the east side of the barn. A band of 6/6 windows light the front (south) wall. There is a wide vehicular entrance at the east end and a man door in the middle. Like the other farm buildings, it is covered with clapboard siding. (Interior inspection was not available.) Prior to the construction of this building in the mid-20th c., the milk house was in the north end of the shed.

Photo 4 description: Front (southeast) elevation of barn and milk house
